**Flood Control Project Maintenance
Levee Inspections**

Maintenance Issue Types Only, Levee Inspection Report By Mile - Spring 2019

Reclamation District No. 2060 Hastings

Waterway	Bank	Unit Miles	Inspection Start/End	Inspector
Unit No. 01 Lindsey Slough	Left	6.97	04/09/2019 04/09/2019	David Julian

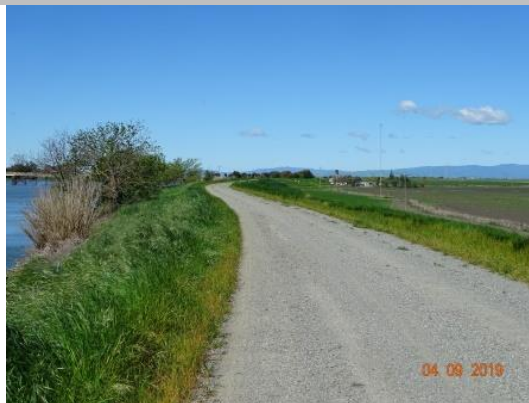
Photo 1 of 1 : SP_2019_RD2060_241_17_20190409_00073.jpg

LM Start	0.01	Rating **	U	Issue No.	17
LM End	5.09	Issue Type +	Ma	Location *	LS
Category	Earthen Levee			GPS Latitude/Longitude	
				Start	End
Item	Vegetation			38.247263 °	38.263303 °
				-121.696472 °	-121.771737 °
DWR ID	DWR_RD2060_01_s_2019_17				
Comment Code					
V1 : Control annual grass and weeds on the levee slopes and easements.					
Inspector Comment					
Maintain annual vegetation

View looking upstream at annual vegetation on the landside slope (Spring 2019).

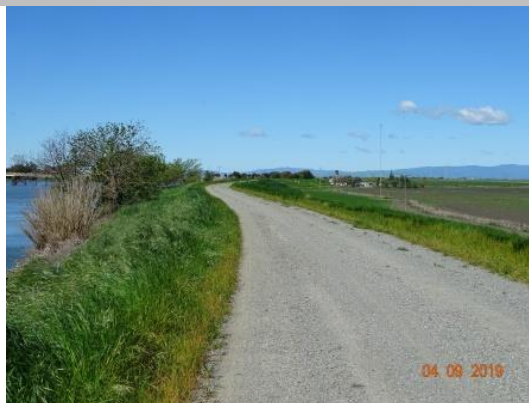
Photo 1 of 1 : SP_2019_RD2060_241_35_20190409_00074.jpg

LM Start	0.01	Rating **	U	Issue No.	35
LM End	5.09	Issue Type +	Ma	Location *	WS
Category	Earthen Levee			GPS Latitude/Longitude	
				Start	End
Item	Vegetation			38.247262 °	38.263303 °
				-121.696472 °	-121.771737 °
DWR ID	DWR_RD2060_01_s_2019_35				
Comment Code					
V1 : Control annual grass and weeds on the levee slopes and easements.					
Inspector Comment					
Maintain annual vegetation

View looking upstream at annual vegetation on the waterside slope (Spring 2019).

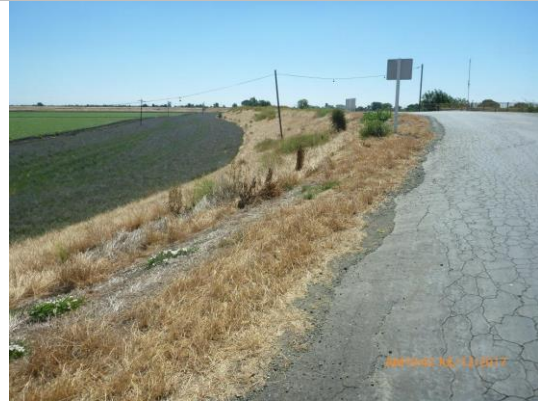
Photo 5 of 6 : SP_2019_RD2060_241_5_20190311_00005.jpg

LM Start	0.40	Rating **	M	Issue No.	5 (cont)	
LM End	0.40	Issue Type +	Ma	Location *	WS	
Category	Supplemental			GPS Latitude/Longitude		
				Start	End	
Item	2017 Storm Damage			38.247894 °	38.247911 °	
				-121.703492 °	-121.703539 °	
DWR ID	DWR_RD2060_01_f_2017_5					
Comment Code						
Inspector Comment						
Levee Evaluation Comments						
Description:Erosion commences approximately 3/4 of the way down the slope, near the water line towards the waterside toe.						
Site ID No:358						
Site Designation:LMA-185						
Repair Type: Erosion						
Rating:Area of Concern						
Field Date:7/12/2017						
Notes: Small erosion into bank.

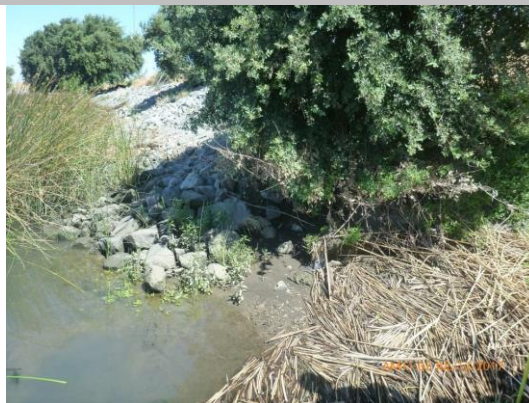
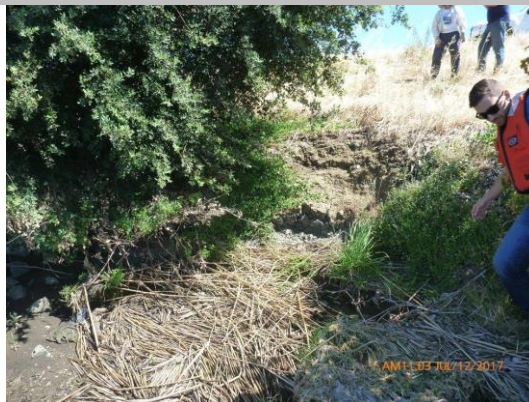
LM Start	0.41	Rating **	M	Issue No.	8 (cont)	
LM End	0.42	Issue Type +	Ma	Location *	WS	
Category	Supplemental			GPS Latitude/Longitude		
				Start	End	
Item	2017 Storm Damage			38.248036 °	38.248017 °	
				-121.703539 °	-121.703789 °	
DWR ID	DWR_RD2060_01_f _ 2017_8					
Comment Code						
Inspector Comment						
<p>Levee Evaluation Comments</p> <p>Description:Erosion commences approximately halfway down the water side slope extending in to existing rip rap. Existing rip rap appears to have been pulled off in this section.</p> <p>Site ID No:359</p> <p>Site Designation:LMA-186</p> <p>Repair Type: Erosion</p> <p>Rating:Area of Concern</p> <p>Field Date:7/12/2017</p> <p>Notes: Site had riprap but is eroded away. Minor erosion in toe of levee.</p>

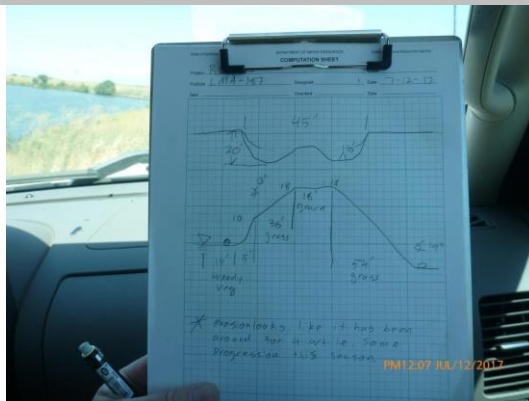
Photo 3 of 3 : SP_2019_RD2060_241_9_20190311_00012.jpg

LM Start	0.75	Rating **	M	Issue No.	9 (cont)
LM End	0.76	Issue Type +	Ma	Location *	WS
Category	Supplemental		GPS Latitude/Longitude		
			Start	End	
Item	2017 Storm Damage		38.249314 °	38.249400 °	
			-121.709461 °	-121.709608 °	
DWR ID	DWR_RD2060_01_f_2017_9				
Comment Code					
Inspector Comment					
<p>Levee Evaluation Comments</p> <p>Description: Erosion commences approximately halfway down the water side slope extending in to existing rip rap. Erosion is concentrated near the waterline. Existing rip rap appears to have been pulled off in this section.</p> <p>Site ID No: 360</p> <p>Site Designation: LMA-187</p> <p>Repair Type: Erosion</p> <p>Rating: Area of Concern</p> <p>Field Date: 7/12/2017</p> <p>Notes: Erosion looks old but has progressed this year.</p>

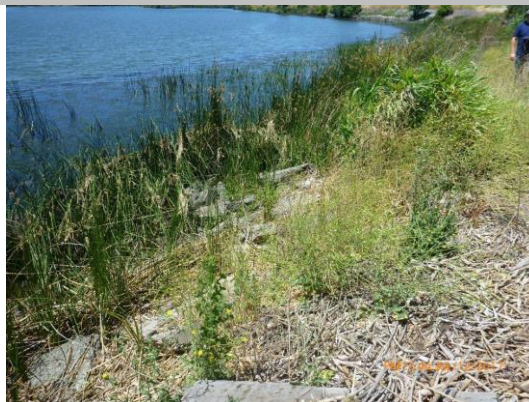
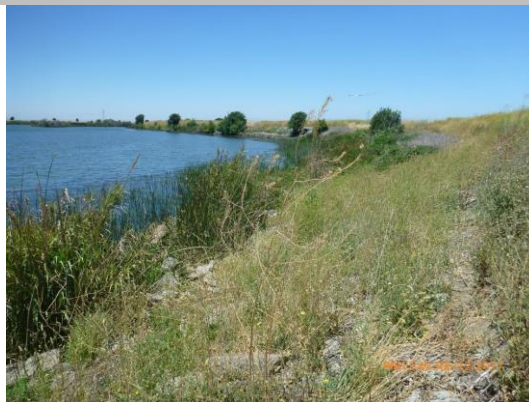
LM Start	0.92	Rating **	M	Issue No.	10
LM End	0.93	Issue Type +	Ma	Location *	WS
Category	Supplemental			GPS Latitude/Longitude	
				Start	End
Item	2017 Storm Damage			38.250875 °	38.250953 °
				-121.711942 °	-121.712078 °
DWR ID	DWR_RD2060_01_f_2018_10				
Comment Code					
Inspector Comment					
Levee Evaluation Comments					
Description:Sloughing commences approximately halfway down the water side slope.					
Site ID No:361					
Site Designation:LMA-188					
Repair Type: Erosion					
Rating:Area of Concern					
Field Date:7/12/2017					
Notes: Minor sloughing, mostly riprap has moved down the slope and into channel.

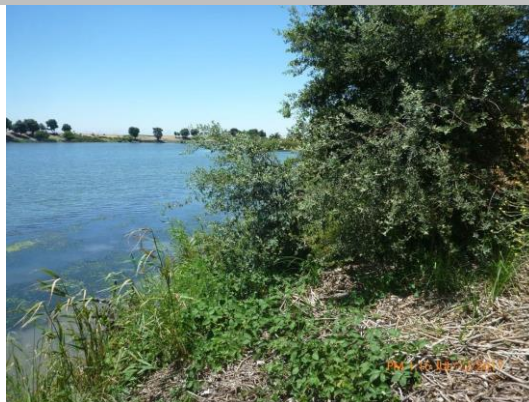
Photo 2 of 3 : SP_2019_RD2060_241_15_20190311_00018.jpg

LM Start	1.04	Rating **	M	Issue No.	15
LM End	1.08	Issue Type +	Ma	Location *	WS
Category	Supplemental			GPS Latitude/Longitude	
				Start	End
Item	2017 Storm Damage			38.251058 °	38.250872 °
				-121.714050 °	-121.714792 °
DWR ID	DWR_RD2060_01_f_2017_15				
Comment Code					
Inspector Comment					
Levee Evaluation Comments Description:Erosion commences approximately 3/4 of the way down the water side slope concentrated at the waterline. Site ID No:362 Site Designation:LMA-189 Repair Type: Erosion Rating:Area of Concern Field Date:7/12/2017 Notes: Erosion due to lack of revetment. Erosion ends at riprap downstream. Vertical cut at summer wse.

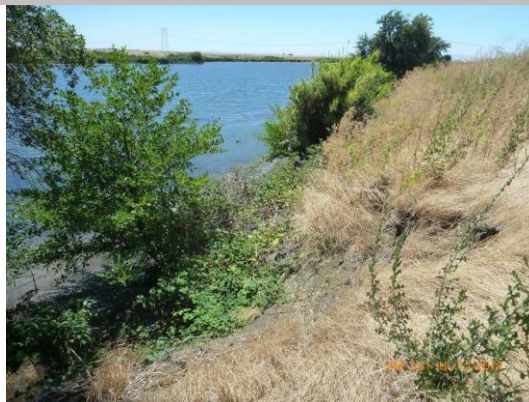
Photo 2 of 3 : SP_2019_RD2060_241_20_20190311_00024.jpg

LM Start	1.39	Rating **	A/W	Issue No.	20
LM End	1.56	Issue Type +	Ma	Location *	WS
Category	Supplemental			GPS Latitude/Longitude	
				Start	End
Item	2017 Storm Damage			38.251886 °	38.252619 °
				-121.719933 °	-121.722842 °
DWR ID	DWR_RD2060_01_f_2017_20				
Comment Code					
Inspector Comment					
Levee Evaluation Comments					
Description:Erosion commences approximately halfway down the water side slope extending to the toe.					
Site ID No:365					
Site Designation:LMA-192					
Repair Type: Erosion					
Rating:Serious					
Field Date:7/12/2017					
Notes: Several deep narrow cuts into levee, but mostly minor erosion at highwater line.

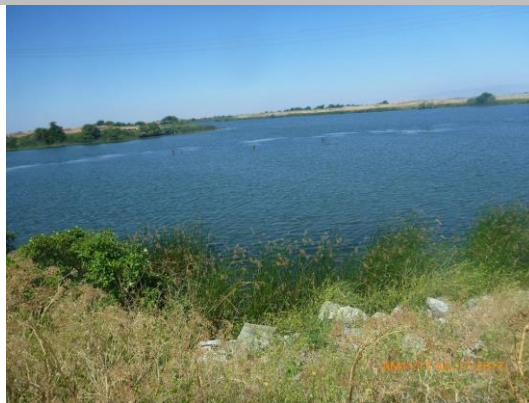
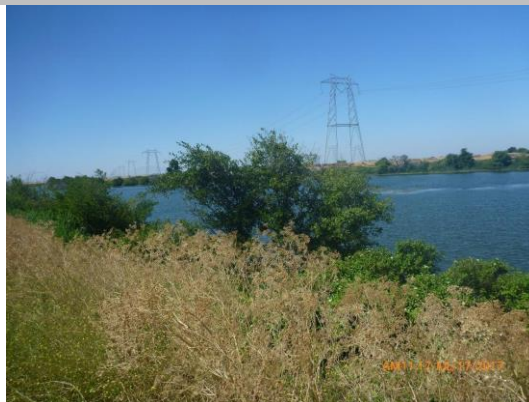
LM Start	1.90	Rating **	M	Issue No.	22 (cont)
LM End	1.95	Issue Type +	Ma	Location *	WS
Category	Supplemental			GPS Latitude/Longitude	
				Start	End
Item	2017 Storm Damage			38.257208 °	38.257842 °
				-121.724619 °	-121.724694 °
DWR ID	DWR_RD2060_01_f_2017_22				
Comment Code					
Inspector Comment					
Levee Evaluation Comments					
Description:Erosion commences approximately halfway down the water side slope extending to the toe. Some slipping into the toe has occurred.					
Site ID No:367					
Site Designation:LMA-194					
Repair Type: Erosion					
Rating:Area of Concern					
Field Date:7/12/2017					
Notes: Minor crackingobserved below the hinge point and minor erosion at levee toe.

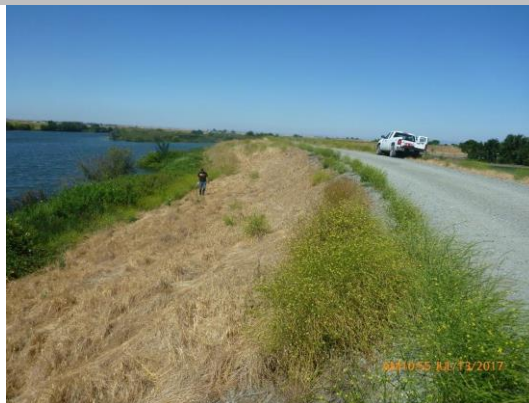
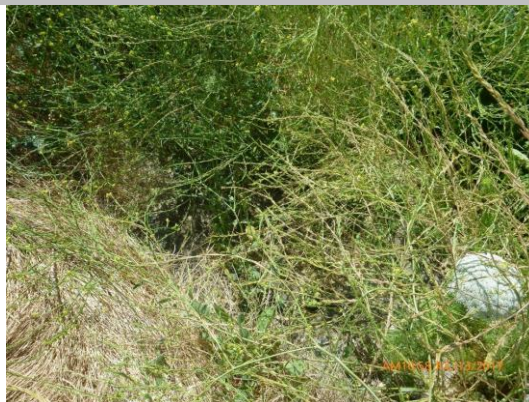
LM Start	2.57	Rating **	M	Issue No.	24 (cont)
LM End	2.60	Issue Type +	Ma	Location *	WS
Category	Supplemental			GPS Latitude/Longitude	
				Start	End
Item	2017 Storm Damage			38.257467 °	38.257286 °
				-121.734153 °	-121.734683 °
DWR ID	DWR_RD2060_01_f_2017_24				
Comment Code					
Inspector Comment					
Levee Evaluation Comments					
Description:Erosion commences approximately halfway down the water side slope. Part of the levee has sloughed down toward the waterline where further erosion occurs.					
Site ID No:369					
Site Designation:LMA-196					
Repair Type: Erosion					
Rating:Area of Concern					
Field Date:7/13/2017					
Notes: Levee slope is concave due slumping. Erosion at waterline.

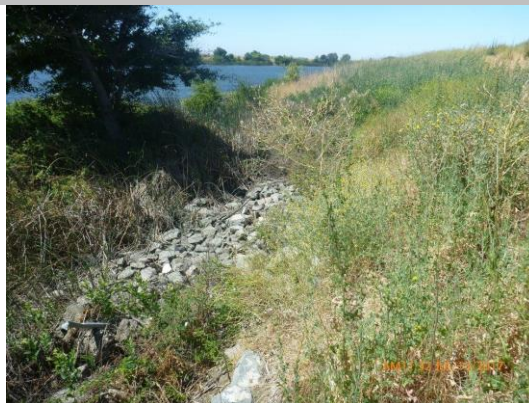
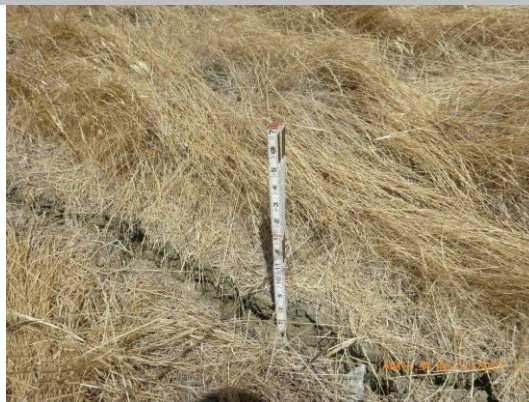
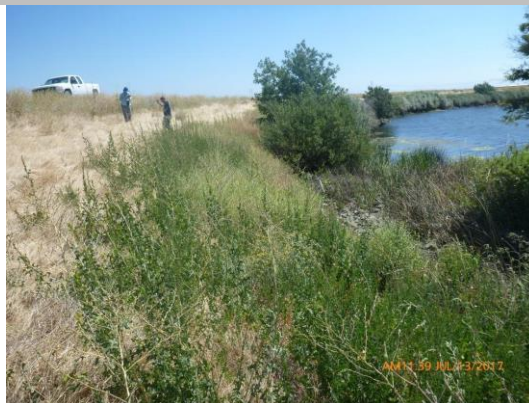
LM Start	3.07	Rating **	A/W	Issue No.	25
LM End	3.10	Issue Type +	Ma	Location *	
Category	Supplemental			GPS Latitude/Longitude	
				Start	End
Item	2017 Storm Damage			38.260772 °	38.260569 °
				-121.740817 °	-121.741194 °
DWR ID	DWR_RD2060_01_f_2017_25				
Comment Code					
Inspector Comment					
Levee Evaluation Comments					
Description:Erosion occurs near the waterline. Part of the levee has sloughed down toward the waterline due to erosion.					
Site ID No:370					
Site Designation:LMA-197					
Repair Type: Erosion					
Rating:Serious					
Field Date:7/13/2017					
Notes: Large erosion halfway into levee. Horizontal cracking on slope almost 24" deep.

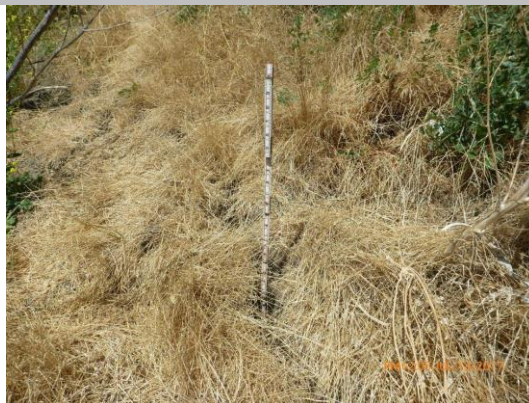
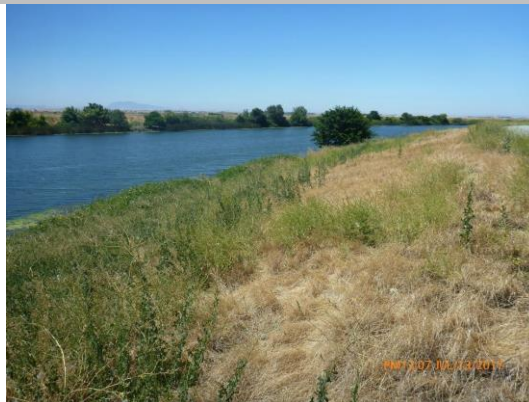
LM Start	3.17	Rating **	M	Issue No.	26 (cont)	
LM End	3.17	Issue Type +	Ma	Location *		
Category	Supplemental			GPS Latitude/Longitude		
				Start	End	
Item	2017 Storm Damage			38.259925 °	38.259903 °	
				-121.742236 °	-121.742281 °	
DWR ID	DWR_RD2060_01_f_2017_26					
Comment Code						
Inspector Comment						
Levee Evaluation Comments						
Description:Erosion occurs near the waterline.						
Site ID No:371						
Site Designation:LMA-198						
Repair Type: Erosion						
Rating:Area of Concern						
Field Date:7/13/2017						
Notes: Minor erosion with sloughing. Horizontal cracks 3.5' deep.

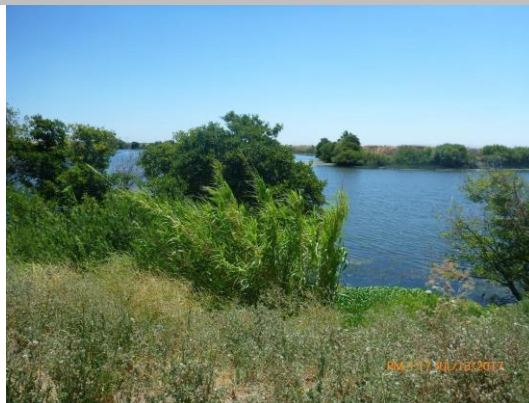
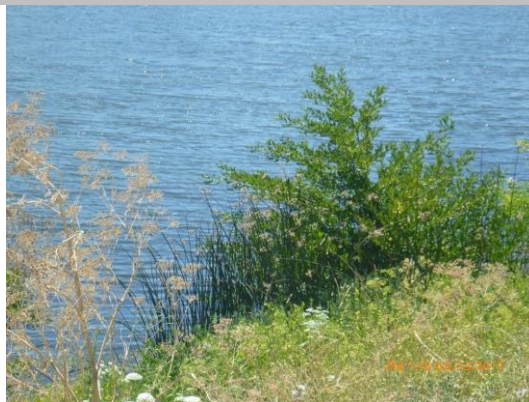
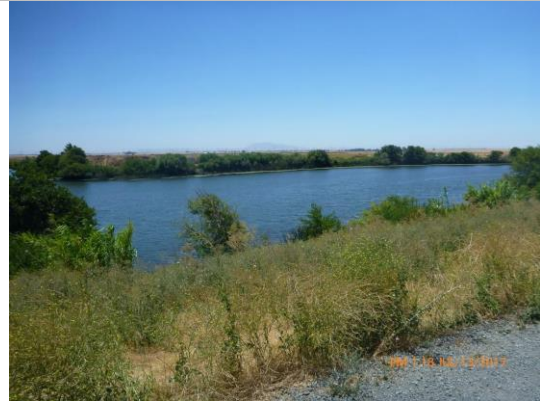
LM Start	3.60	Rating **	M	Issue No.	27
LM End	3.61	Issue Type +	Ma	Location *	
Category	Supplemental			GPS Latitude/Longitude	
				Start	End
Item	2017 Storm Damage			38.261469 °	38.261464 °
				-121.748389 °	-121.748442 °
DWR ID	DWR_RD2060_01_f_2017_27				
Comment Code					
Inspector Comment					
Levee Evaluation Comments					
Description:Erosion commences halfway down the slope and extends to the toe. Erosion is concentrated at the water line.					
Site ID No:373					
Site Designation:LMA-200					
Repair Type: Erosion					
Rating:Area of Concern					
Field Date:7/13/2017					
Notes: Small erosion with a narrow deep cut. Heavy veg is protecting the slope.

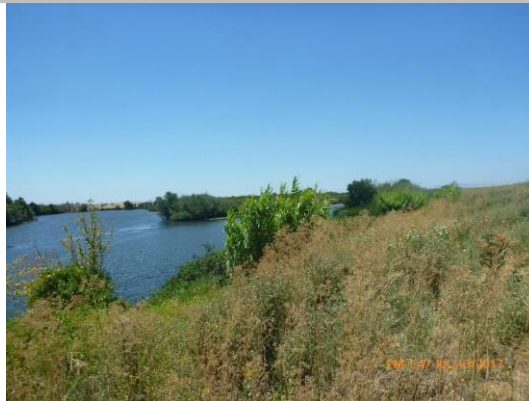
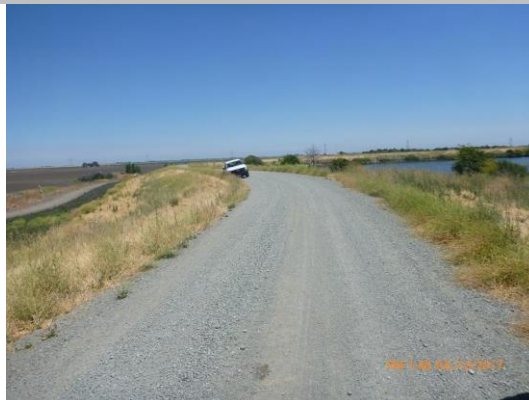
Levee Evaluation Comments
 Description: Erosion is concentrated near the water line.
 Site ID No: 374
 Site Designation: LMA-201
 Repair Type: Erosion
 Rating: Area of Concern
 Field Date: 7/13/2017
 Notes: Small narrow and deep cut. May have been caused by a collapsed beaver den.

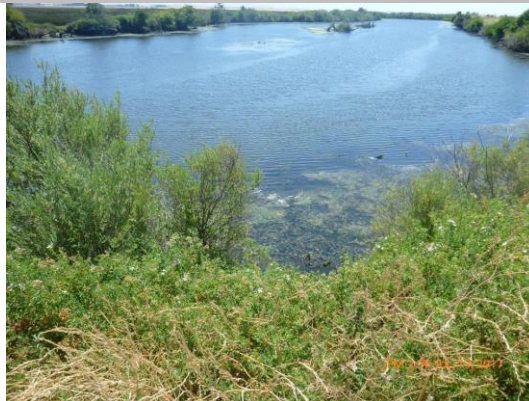
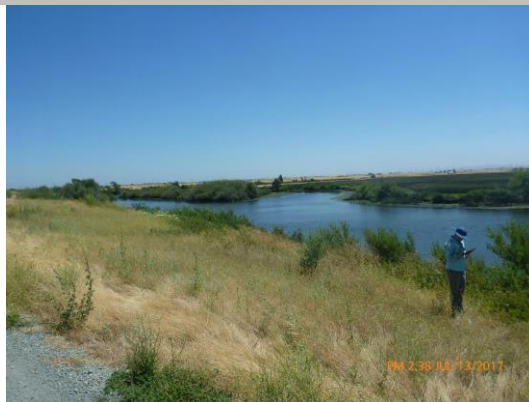
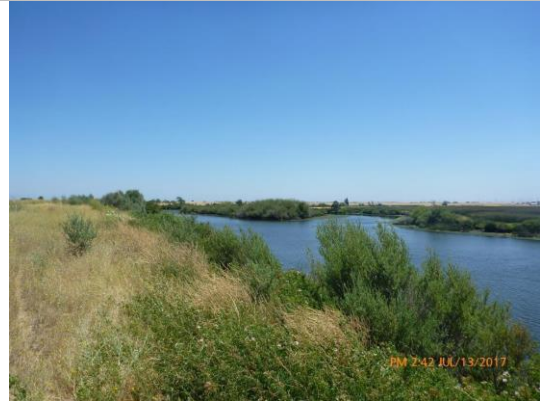
LM Start	4.28	Rating **	A/W	Issue No.	29
LM End	4.28	Issue Type +	Ma	Location *	
Category	Supplemental			GPS Latitude/Longitude	
				Start	End
Item	2017 Storm Damage			38.260992 °	38.261017 °
				-121.759806 °	-121.759847 °
DWR ID	DWR_RD2060_01_f_2017_29				
Comment Code					
Inspector Comment					
Levee Evaluation Comments					
Description:Erosion commences halfway down the slope and extends to the toe. Erosion is concentrated at the water line.					
Site ID No:376					
Site Designation:LMA-203					
Repair Type: Erosion					
Rating:Area of Concern					
Field Date:7/13/2017					
Notes: Could not get to erosion due to dense veg. Possibly a deep narrow cut.

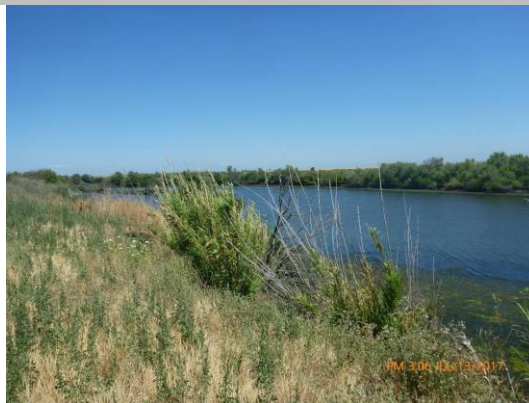
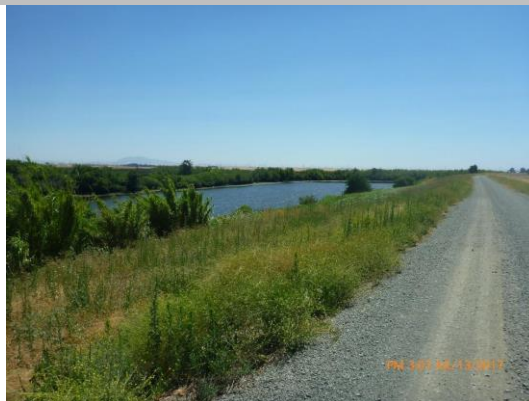
LM Start	4.40	Rating **	M	Issue No.	30 (cont)	
LM End	4.46	Issue Type +	Ma	Location *		
Category	Supplemental			GPS Latitude/Longitude		
				Start	End	
Item	2017 Storm Damage			38.260850 °	38.260425 °	
				-121.761875 °	-121.762861 °	
DWR ID	DWR_RD2060_01_f_2017_30					
Comment Code						
Inspector Comment						
Levee Evaluation Comments						
Description:Erosion/sloughing commences approximately halfway down the slope. Erosion is concentrated mostly near the water line and has resulting in slippage of the slope.						
Site ID No:377						
Site Designation:LMA-204						
Repair Type: Erosion						
Rating:Area of Concern						
Field Date:7/13/2017						
Notes: large cut is 100' of 320' site. Large cut is 12' vertical and the rest is 6'.

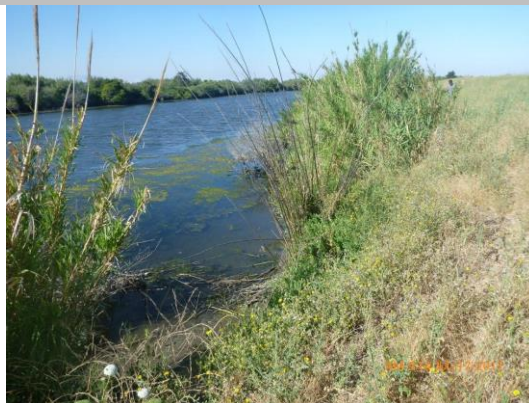
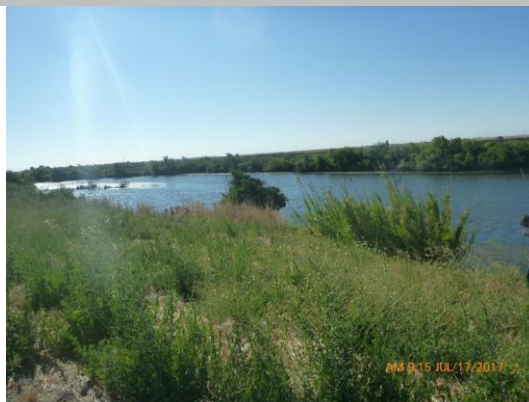
LM Start	4.50	Rating **	A/W	Issue No.	31
LM End	4.53	Issue Type +	Ma	Location *	
Category	Supplemental			GPS Latitude/Longitude	
				Start	End
Item	2017 Storm Damage			38.260150 °	38.259939 °
				-121.763556 °	-121.764064 °
DWR ID	DWR_RD2060_01_f_2017_31				
Comment Code					
Inspector Comment					
Levee Evaluation Comments					
Description:Erosion commences approximately 3/4 of the way down the slope. It has resulted in some sloughing.					
Site ID No:378					
Site Designation:LMA-205					
Repair Type: Erosion					
Rating:Serious					
Field Date:7/17/2017					
Notes: Deep, wide, vertical cut into slope almost 1/2 way into sope.

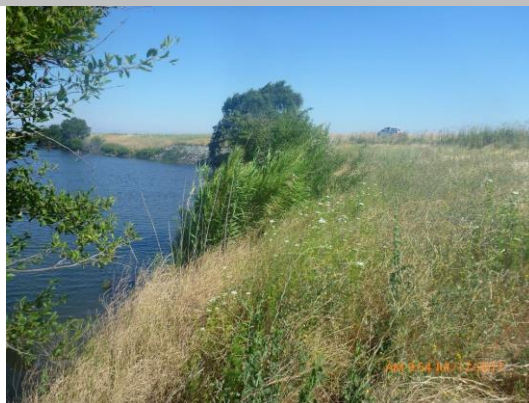
LM Start	4.80	Rating **	A/W	Issue No.	32 (cont)	
LM End	4.88	Issue Type +	Ma	Location *		
Category	Supplemental			GPS Latitude/Longitude		
				Start	End	
Item	2017 Storm Damage			38.260714 °	38.261808 °	
				-121.767972 °	-121.768536 °	
DWR ID	DWR_RD2060_01_f _ 2017_32					
Comment Code						
Inspector Comment						
Levee Evaluation Comments						
Description:Erosion/sloughing commences approximately halfway down the slope. Erosion is concentrated mostly near the water line and has resulting in slippage of the slope towards the toe.						
Site ID No:379						
Site Designation:LMA-206						
Repair Type: Erosion						
Rating:Serious						
Field Date:7/17/2017						
Notes: Several erosions with slumping. Fresh soil indicates active erosion this season. Adjacent slope has riprap. Riprap should be extended along this stretch.

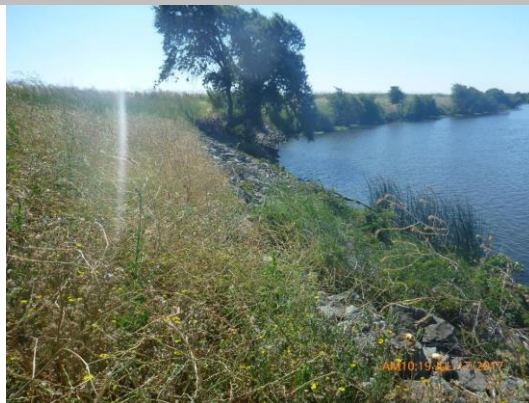
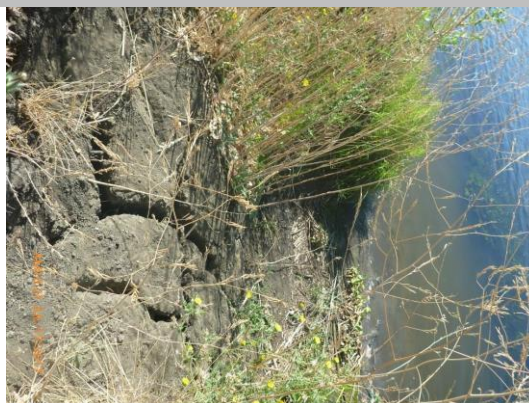
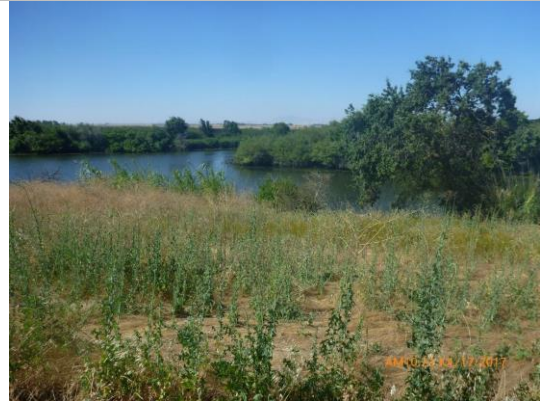
LM Start	4.92	Rating **	M	Issue No.	33
LM End	4.92	Issue Type +	Ma	Location *	
Category	Supplemental			GPS Latitude/Longitude	
				Start	End
Item	2017 Storm Damage			38.262128 °	38.262128 °
				-121.769175 °	-121.769175 °
DWR ID	DWR_RD2060_01_f_2017_33				
Comment Code					
Inspector Comment					
Levee Evaluation Comments					
Description:Erosion/sloughing commences approximately halfway down the slope. Erosion is concentrated mostly near the water line and has resulting in slippage of the slope into the toe.					
Site ID No:380					
Site Designation:LMA-207					
Repair Type: Erosion					
Rating:Area of Concern					
Field Date:7/17/2017					
Notes: Reduced length of site from 275 to 62. No widespread erosion, just 2 small erosions upstream from adjacent riprap.

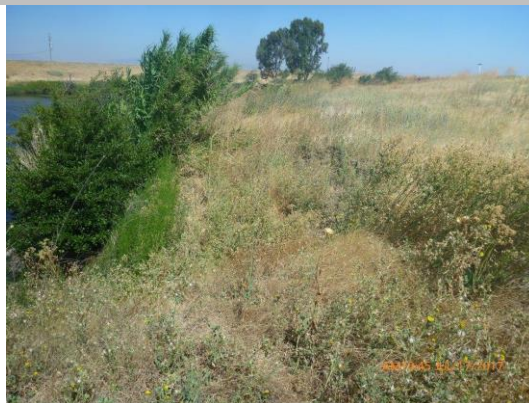
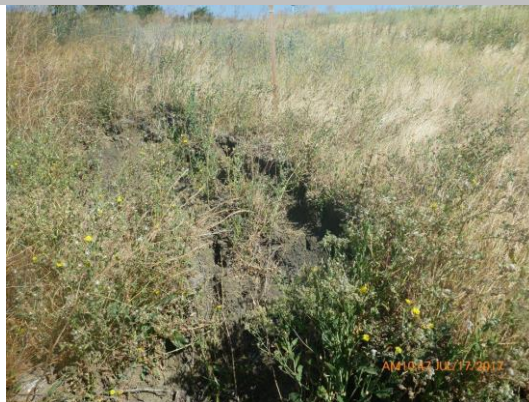
LM Start	5.00	Rating **	M	Issue No.	34 (cont)
LM End	5.01	Issue Type +	Ma	Location *	
Category	Supplemental			GPS Latitude/Longitude	
				Start	End
Item	2017 Storm Damage			38.262636 °	38.262658 °
				-121.770503 °	-121.770547 °
DWR ID	DWR_RD2060_01_f_2017_34				
Comment Code					
Inspector Comment					
Levee Evaluation Comments					
Description:Erosion is concentrated mostly near the water line and has resulting in slippage of the slope into the toe.					
Site ID No:381					
Site Designation:LMA-208					
Repair Type: Erosion					
Rating:Area of Concern					
Field Date:7/17/2017					
Notes: Extended site from 15' to 75' to include LMA-209. Small erosions will become 1 site next high water due to sloughing between them.

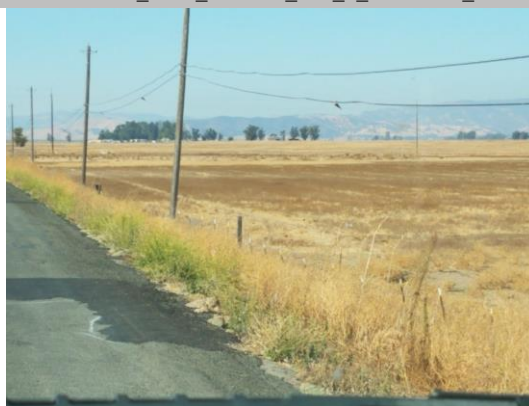
LM Start	0.74	Rating **	M	Issue No.	7
LM End	2.14	Issue Type +	Ma	Location *	WS
Category	Earthen Levee			GPS Latitude/Longitude	
				Start	End
Item	Vegetation			38.285189 °	38.290464 °
				-121.795415 °	-121.774855 °
DWR ID	DWR_RD2060_02_f_2018_7				
Comment Code					
V1 : Control annual grass and weeds on the levee slopes and easements.					
Inspector Comment					
Maintain vegetation on water side slope

View of vegetation on water side slope (October 2018)

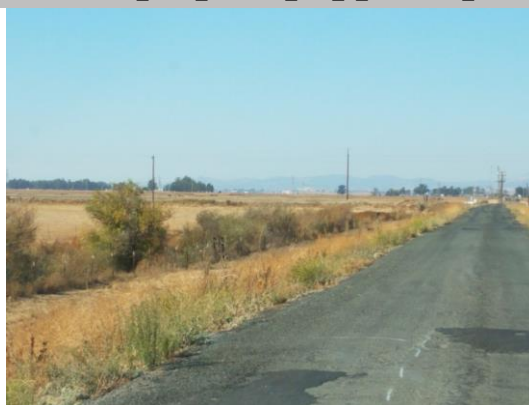
LM Start	0.74	Rating **	M	Issue No.	6
LM End	1.73	Issue Type +	Ma	Location *	LS
Category	Earthen Levee			GPS Latitude/Longitude	
				Start	End
Item	Vegetation			38.285188 °	38.285143 °
				-121.795334 °	-121.777128 °
DWR ID	DWR_RD2060_02_f_2018_6				
Comment Code					
V1 : Control annual grass and weeds on the levee slopes and easements.					
Inspector Comment					
Maintain vegetation on land side slope

View of vegetation on land side slope (October 2018)

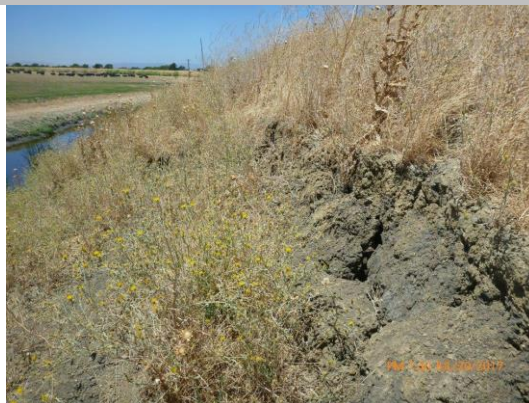
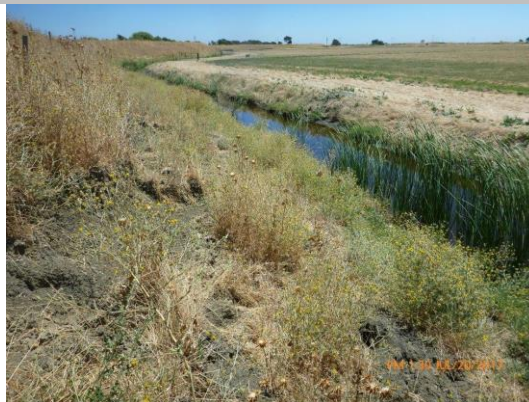
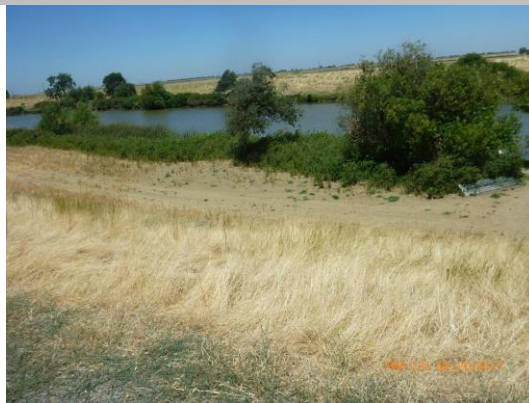
LM Start	0.12	Rating **	M	Issue No.	13
LM End	0.18	Issue Type +	Ma	Location *	
Category	Supplemental			GPS Latitude/Longitude	
				Start	End
Item	2017 Storm Damage			38.295919 °	38.295611 °
				-121.746700 °	-121.745742 °
DWR ID	DWR_RD2060_03_f_2017_13				
Comment Code					
Inspector Comment					
Levee Evaluation Comments					
Description:Sloughing and seepage occurs near the land side toe.					
Site ID No:385					
Site Designation:LMA-212					
Repair Type: Stability					
Rating:Area of Concern					
Field Date:7/20/2017					
Notes: Moderate sloughing halfway down LS slope. Monitor for progression.

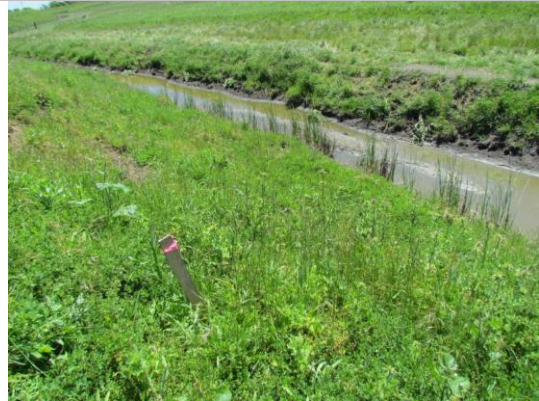
LM Start	0.15	Rating **	A/W	Issue No.	19 (cont)	
LM End	0.19	Issue Type +	Ma	Location *	LS	
Category	Earthen Levee			GPS Latitude/Longitude		
				Start	End	
Item	Slope Stability			38.295738 °	38.295559 °	
				-121.746293 °	-121.745583 °	
DWR ID	DWR_RD2060_03_s_2017_19					
Comment Code						
S1 : Repair slope instability.						
Inspector Comment						
There are several signs of sloughing occuring on the slope.

Just upstream of the erosion site looking downstream from the landside slope.

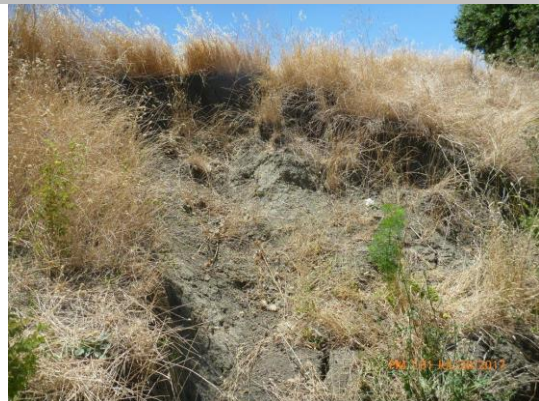
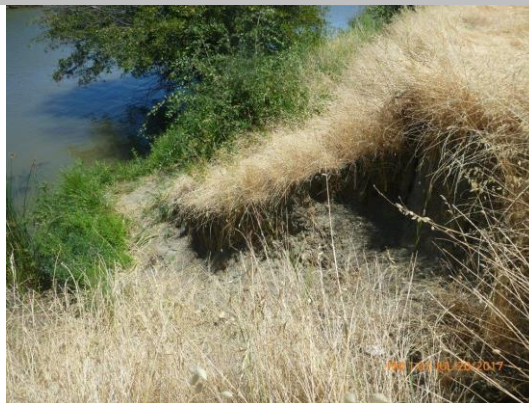
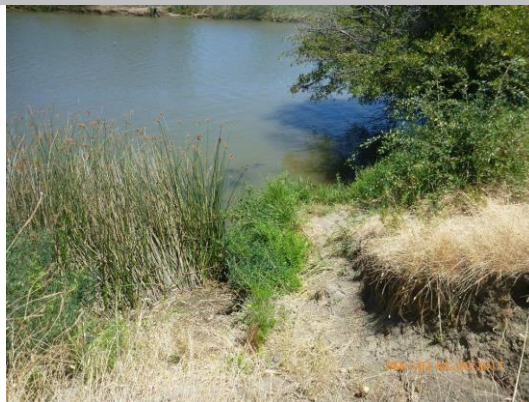
LM Start	0.64	Rating **	M	Issue No.	14
LM End	0.64	Issue Type +	Ma	Location *	
Category	Supplemental			GPS Latitude/Longitude	
				Start	End
Item	2017 Storm Damage			38.292197 °	38.292208 °
				-121.739661 °	-121.739611 °
DWR ID	DWR_RD2060_03_f_2017_14				
Comment Code					
Inspector Comment					
Levee Evaluation Comments					
Description:Erosion commences near the edge of the crown and extends down the slope. Erosion has resulted in slippage into the waterside toe.					
Site ID No:386					
Site Designation:LMA-213					
Repair Type: Erosion					
Rating:Area of Concern					
Field Date:7/20/2017					
Notes:

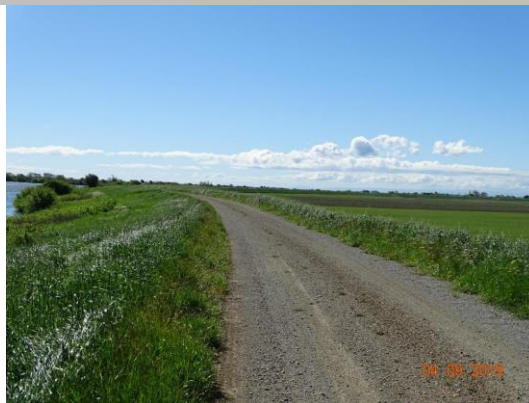
LM Start	0.67	Rating **	U	Issue No.	10
LM End	5.03	Issue Type +	Ma	Location *	LS
Category	Earthen Levee			GPS Latitude/Longitude	
				Start	End
Item	Vegetation			38.292258 °	38.247370 °
				-121.739070 °	-121.696209 °
DWR ID	DWR_RD2060_03_s_2019_10				
Comment Code					
V1 : Control annual grass and weeds on the levee slopes and easements.					
Inspector Comment					
Maintain annual vegetation

View looking downstream at annual vegetation on the landside slope (Spring 2019).

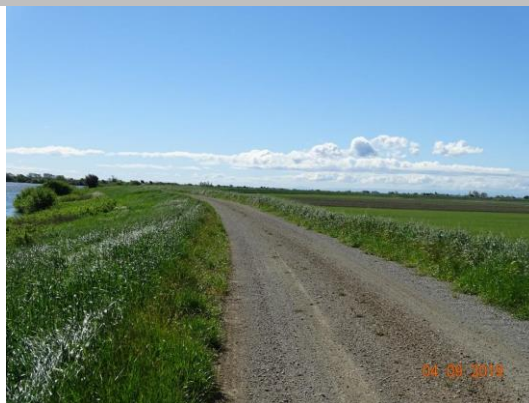
LM Start	0.67	Rating **	U	Issue No.	11
LM End	5.03	Issue Type +	Ma	Location *	WS
Category	Earthen Levee			GPS Latitude/Longitude	
				Start	End
Item	Vegetation			38.292258 °	38.247370 °
				-121.739070 °	-121.696209 °
DWR ID	DWR_RD2060_03_s_2019_11				
Comment Code					
V1 : Control annual grass and weeds on the levee slopes and easements.					
Inspector Comment					
Maintain annual vegetation

View looking downstream at annual vegetation on the waterside slope (Spring 2019).

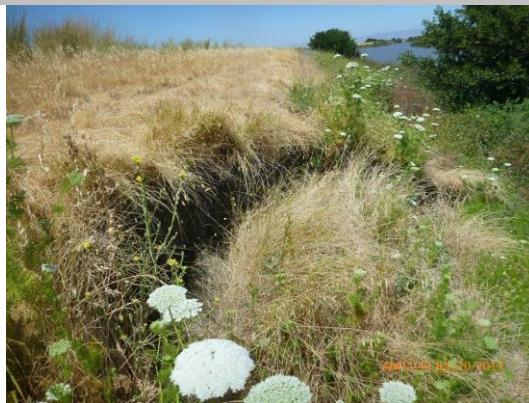
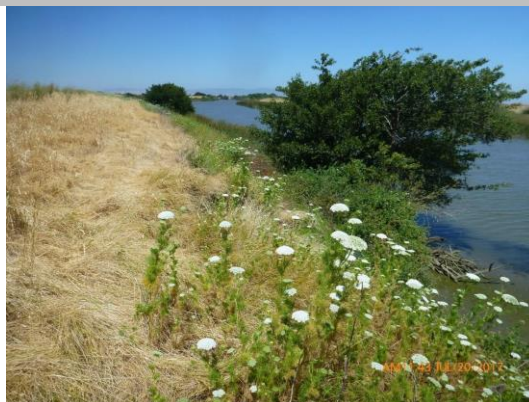
LM Start	1.21	Rating **	M	Issue No.	20
LM End	1.23	Issue Type +	Ma	Location *	
Category	Supplemental			GPS Latitude/Longitude	
				Start	End
Item	2017 Storm Damage			38.290511 °	38.290486 °
				-121.729867 °	-121.729603 °
DWR ID	DWR_RD2060_03_f _ 2017_20				
Comment Code					
Inspector Comment					
Levee Evaluation Comments					
Description:Erosion commences 1/4 of the way down the slope with					
slippage towards the water side toe.					
Site ID No:390					
Site Designation:LMA-217					
Repair Type: Erosion					
Rating:Area of Concern					
Field Date:7/20/2017					
Notes: Erosion halfway down WS slope. Monitor for progression.

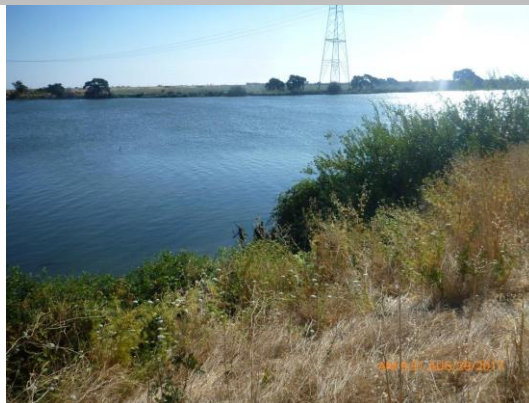
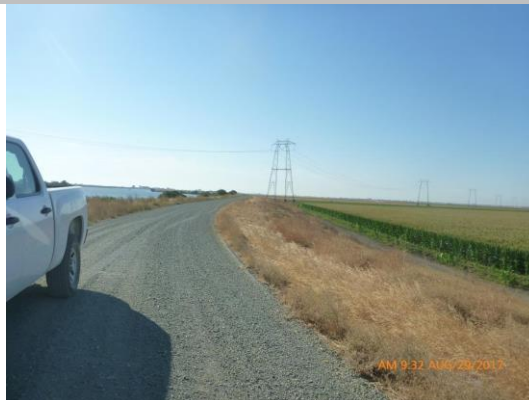
LM Start	1.38	Rating **	M	Issue No.	21 (cont)	
LM End	1.42	Issue Type +	Ma	Location *		
Category	Supplemental			GPS Latitude/Longitude		
				Start	End	
Item	2017 Storm Damage			38.290067 °	38.289608 °	
				-121.726839 °	-121.726344 °	
DWR ID	DWR_RD2060_03_f_2017_21					
Comment Code						
Inspector Comment						
Levee Evaluation Comments						
Description:MBK Delta Erosion Sites_6-29-2017						
Site ID No:482						
Site Designation:LMA-320						
Repair Type: Erosion						
Rating:Area of Concern						
Field Date:8/29/2017						
Notes:

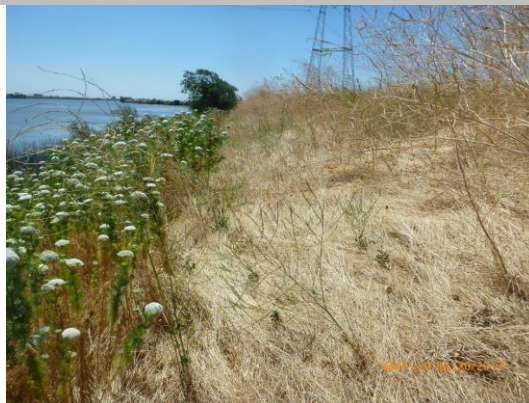
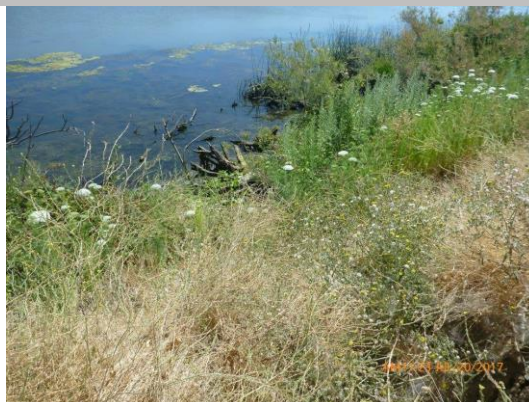
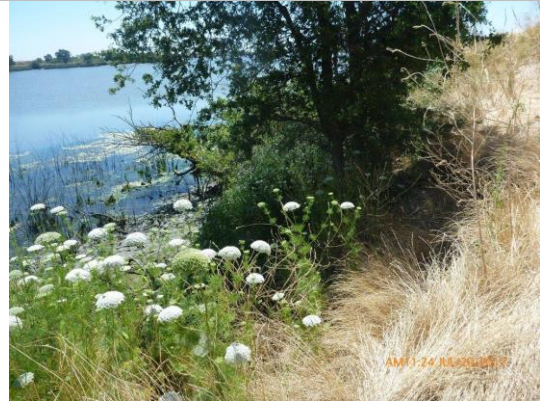
Levee Evaluation Comments
Description: Erosion commences halfway down the slope and results in slippage into the waterside toe.
Site ID No: 392
Site Designation: LMA-219
Repair Type: Erosion
Rating: Area of Concern
Field Date: 7/20/2017
Notes: Moderate erosion present on WS slope. Monitor for progression.

LM Start	1.45	Rating **	M	Issue No.	22 (cont)	
LM End	1.59	Issue Type +	Ma	Location *		
Category	Supplemental			GPS Latitude/Longitude		
				Start	End	
Item	2017 Storm Damage			38.289256 °	38.287689 °	
				-121.726050 °	-121.724658 °	
DWR ID	DWR_RD2060_03_f _ 2017_22					
Comment Code						
Inspector Comment						
Levee Evaluation Comments						
Description:Erosion commences halfway down the slope and results in						
slippage into the waterside toe.						
Site ID No:392						
Site Designation:LMA-219						
Repair Type: Erosion						
Rating:Area of Concern						
Field Date:7/20/2017						
Notes: Moderate erosion present on WS slope. Monitor for progression.

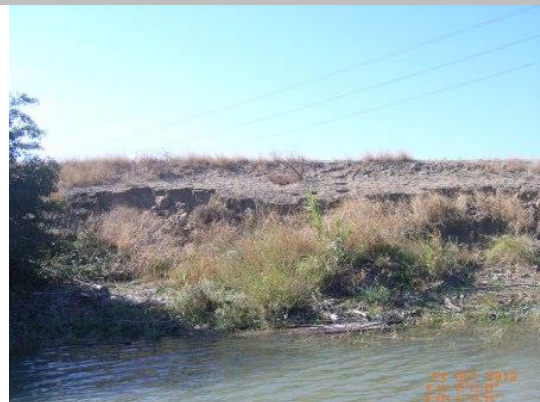
LM Start	1.52	Rating **	A/W	Issue No.	7
LM End	1.74	Issue Type +	Ma	Location *	WS
Category	Supplemental			GPS Latitude/Longitude	
				Start	End
Item	2017 USACE Erosion Survey, DRAFT			38.288598 °	38.286051 °
				-121.725184 °	-121.722818 °
DWR ID	DWR_RD2060_03_f_2018_7				
Comment Code					
Inspector Comment					
2017 Site ID: CHS 23.6 R					
Status: Eroding					
2017 Field Notes: No observed changes.					
Site History: Site added in 1997 and removed in 2003. 2005 - Put back in the inventory. 2006 - Stone repair at the middle of the site. 2011 - Some rock place at toe in the past year. 2013 - Site extended both upstream and downstream to include new erosion pockets.

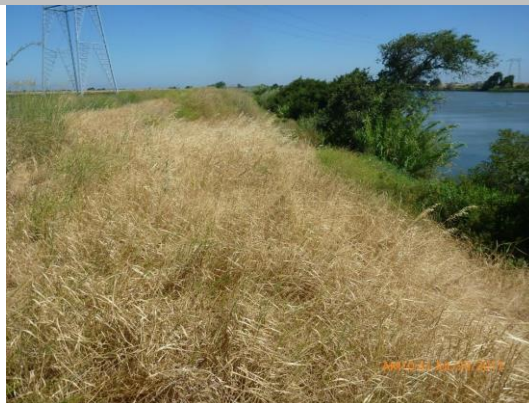
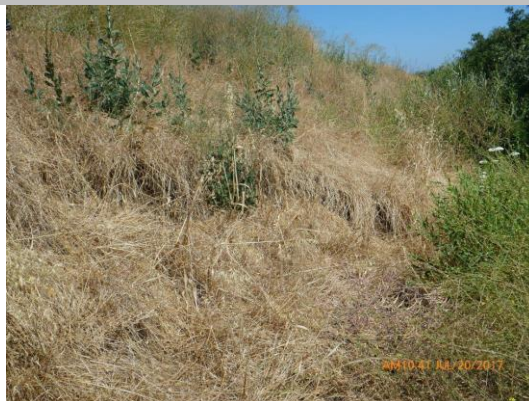
LM Start	1.62	Rating **	A/W	Issue No.	23
LM End	1.63	Issue Type +	Ma	Location *	
Category	Supplemental			GPS Latitude/Longitude	
				Start	End
Item	2017 Storm Damage			38.287336 °	38.287222 °
				-121.724364 °	-121.724253 °
DWR ID	DWR_RD2060_03_f_2017_23				
Comment Code					
Inspector Comment					
Levee Evaluation Comments					
Description:Erosion commences halfway down the slope and results in					
slippage into the waterside toe. Existing rip rap has sloughed into the					
water side toe.					
Site ID No:393					
Site Designation:LMA-220					
Repair Type: Erosion					
Rating:Serious					
Field Date:7/20/2017					
Notes: Moderate sloughing 8ft from WS crown. Erosion at high water					
mark.

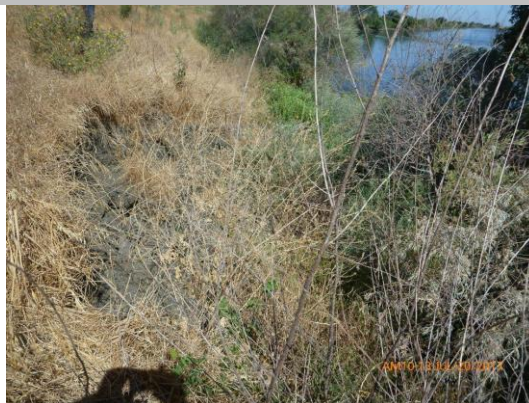
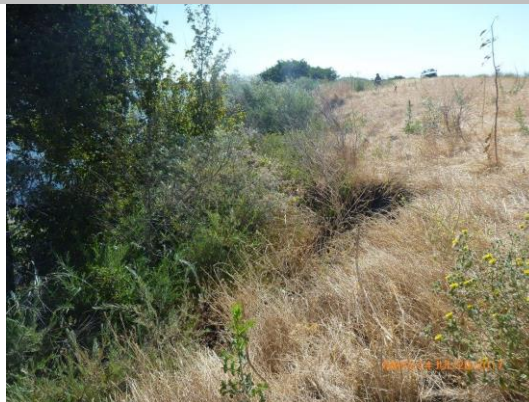
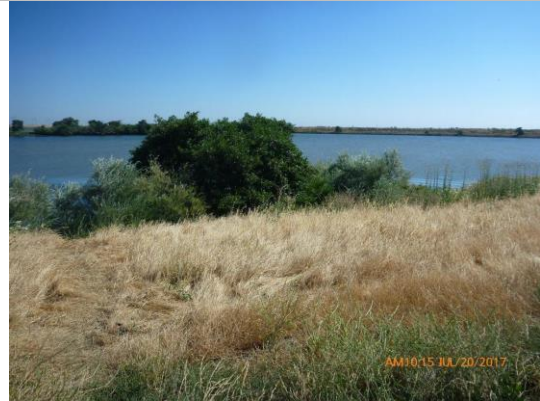
LM Start	1.84	Rating **	M	Issue No.	25
LM End	1.92	Issue Type +	Ma	Location *	
Category	Supplemental			GPS Latitude/Longitude	
				Start	End
Item	2017 Storm Damage			38.284825 °	38.284467 °
				-121.721764 °	-121.720339 °
DWR ID	DWR_RD2060_03_f_2017_25				
Comment Code					
Inspector Comment					
Levee Evaluation Comments					
Description:Erosion commences halfway down the slope and results in					
slippage into the waterside toe.					
Site ID No:395					
Site Designation:LMA-222					
Repair Type: Erosion					
Rating:Area of Concern					
Field Date:7/20/2017					
Notes: Erosion halfway down slope. Monitor for progression.

LM Start	1.84	Rating **	M	Issue No.	25 (cont)	
LM End	1.92	Issue Type +	Ma	Location *		
Category	Supplemental			GPS Latitude/Longitude		
				Start	End	
Item	2017 Storm Damage			38.284825 °	38.284467 °	
				-121.721764 °	-121.720339 °	
DWR ID	DWR_RD2060_03_f _ 2017_25					
Comment Code						
Inspector Comment						
Levee Evaluation Comments						
Description:Erosion commences halfway down the slope and results in						
slippage into the waterside toe.						
Site ID No:395						
Site Designation:LMA-222						
Repair Type: Erosion						
Rating:Area of Concern						
Field Date:7/20/2017						
Notes: Erosion halfway down slope. Monitor for progression.

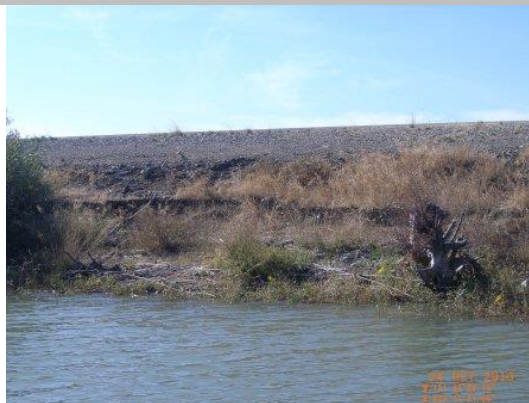
LM Start	2.02	Rating **	A/W	Issue No.	6
LM End	2.08	Issue Type +	Ma	Location *	WS
Category	Supplemental			GPS Latitude/Longitude	
				Start	End
Item	2017 USACE Erosion Survey, DRAFT			38.284105 °	38.283302 °
				-121.718471 °	-121.717814 °
DWR ID	DWR_RD2060_03_f_2018_6				
Comment Code					
Inspector Comment					
2017 Site ID: CHS 23.0 R					
Status: Eroding					
2017 Field Notes: No observed changes.					
Site History: 2010 - Small maintenance site.

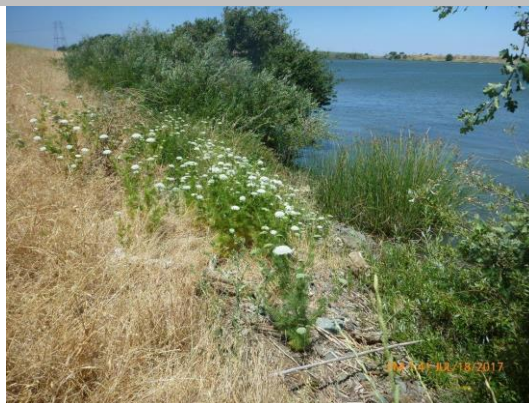
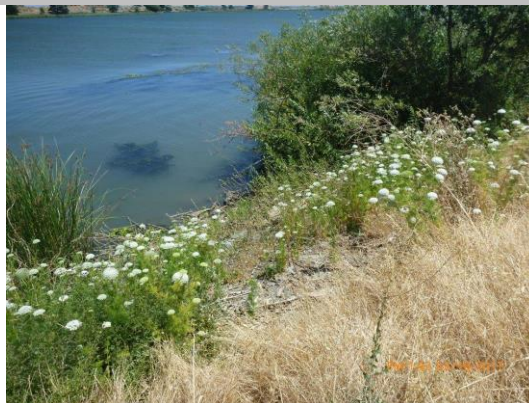
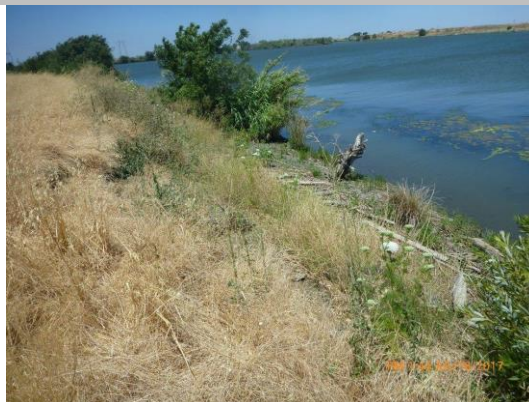
LM Start	2.02	Rating **	M	Issue No.	26
LM End	2.06	Issue Type +	Ma	Location *	
Category	Supplemental			GPS Latitude/Longitude	
				Start	End
Item	2017 Storm Damage			38.283914 °	38.283422 °
				-121.718614 °	-121.718206 °
DWR ID	DWR_RD2060_03_f_2017_26				
Comment Code					
Inspector Comment					
Levee Evaluation Comments					
Description:Erosion commences halfway down the slope and results in slippage into the waterside toe. Existing rip rap has sloughed into the water side toe.					
Site ID No:396					
Site Designation:LMA-223					
Repair Type: Erosion					
Rating:Area of Concern					
Field Date:7/18/2017					
Notes: Erosion to high water line.

LM Start	2.02	Rating **	M	Issue No.	26 (cont)
LM End	2.06	Issue Type +	Ma	Location *	
Category	Supplemental			GPS Latitude/Longitude	
				Start	End
Item	2017 Storm Damage			38.283914 °	38.283422 °
				-121.718614 °	-121.718206 °
DWR ID	DWR_RD2060_03_f_2017_26				
Comment Code					
Inspector Comment					
Levee Evaluation Comments					
Description:Erosion commences halfway down the slope and results in slippage into the waterside toe. Existing rip rap has sloughed into the water side toe.					
Site ID No:396					
Site Designation:LMA-223					
Repair Type: Erosion					
Rating:Area of Concern					
Field Date:7/18/2017					
Notes: Erosion to high water line.

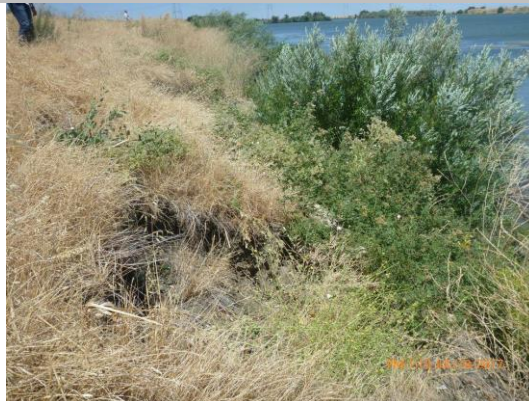
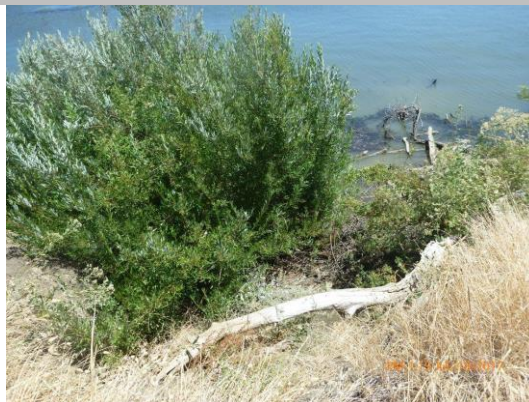
Notes: Benched erosion with large cracks on slope above. Light veg in erosion.

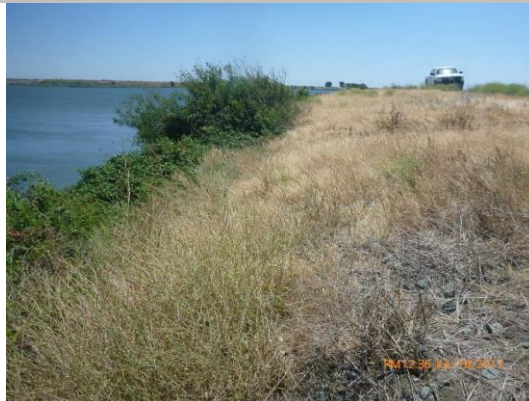
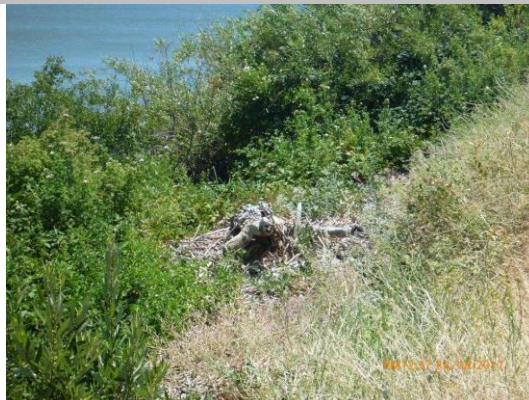
LM Start	2.30	Rating **	M	Issue No.	29
LM End	2.33	Issue Type +	Ma	Location *	
Category	Supplemental			GPS Latitude/Longitude	
				Start	End
Item	2017 Storm Damage			38.280667 °	38.280467 °
				-121.715664 °	-121.715242 °
DWR ID	DWR_RD2060_03_f _ 2017_29				
Comment Code					
Inspector Comment					
Levee Evaluation Comments					
Description:Erosion commences approximately halfway down the slope and results in slippage into the waterside toe.					
Site ID No:399					
Site Designation:LMA-226					
Repair Type: Erosion					
Rating:Area of Concern					
Field Date:7/18/2017					
Notes: Vertical erosion at high water mark.

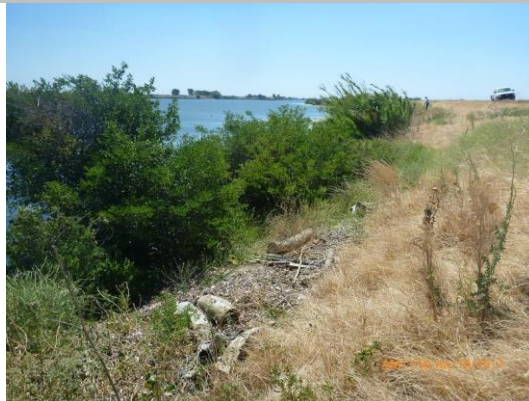
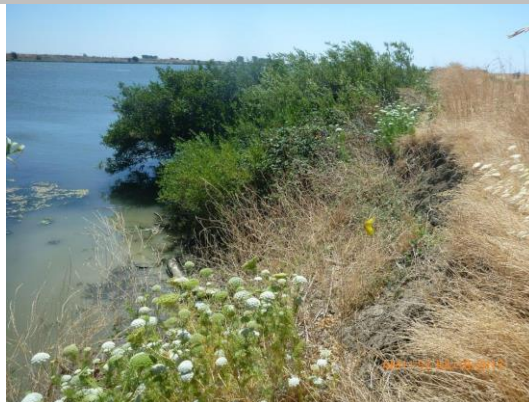
LM Start	2.36	Rating **	M	Issue No.	31 (cont)
LM End	2.43	Issue Type +	Ma	Location *	
Category	Supplemental			GPS Latitude/Longitude	
				Start	End
Item	2017 Storm Damage			38.280208 °	38.279336 °
				-121.714853 °	-121.714172 °
DWR ID	DWR_RD2060_03_f_2017_31				
Comment Code					
Inspector Comment					
Levee Evaluation Comments					
Description:Erosion commences approximately halfway down the slope and results in slippage into the waterside toe.					
Site ID No:400					
Site Designation:LMA-227					
Repair Type: Erosion					
Rating:Area of Concern					
Field Date:7/18/2017					
Notes: Steep cut but protected with heavy woody veg.
